## REPORT No. 087203-004-a

<b>CUSTOMER</b>	CUPA PIZARRAS S.A.
<b>CONTACT PERSON</b>	MARÍA PÉREZ
<b>ADDRESS</b>	LA MEDUA, s/n 32330 SOBRADELO DE VALDEORRAS (ORENSE), SPAIN
<b>PURPOSE</b>	RECOMMENDED DYNAMIC AND STATIC TEST METHOD FOR DETERMINING THE SEISMIC DRIFT CAUSING GLASS FALLOUT FROM A WALL SYSTEM (AAMA 501.6-18, AAMA 501.4-18)
<b>TESTED SAMPLE</b>	VENTILATED CLADDING REF.: "CUPACLAD 101 PARALLEL"
<b>RECEPTION DATE</b>	06.07.2020
<b>TEST DATE</b>	06.07.2020 – 09.07.2020
<b>ISSUE DATE</b>	24.07.2020
<b>TRANSLATION DATE</b>	18.12.2020

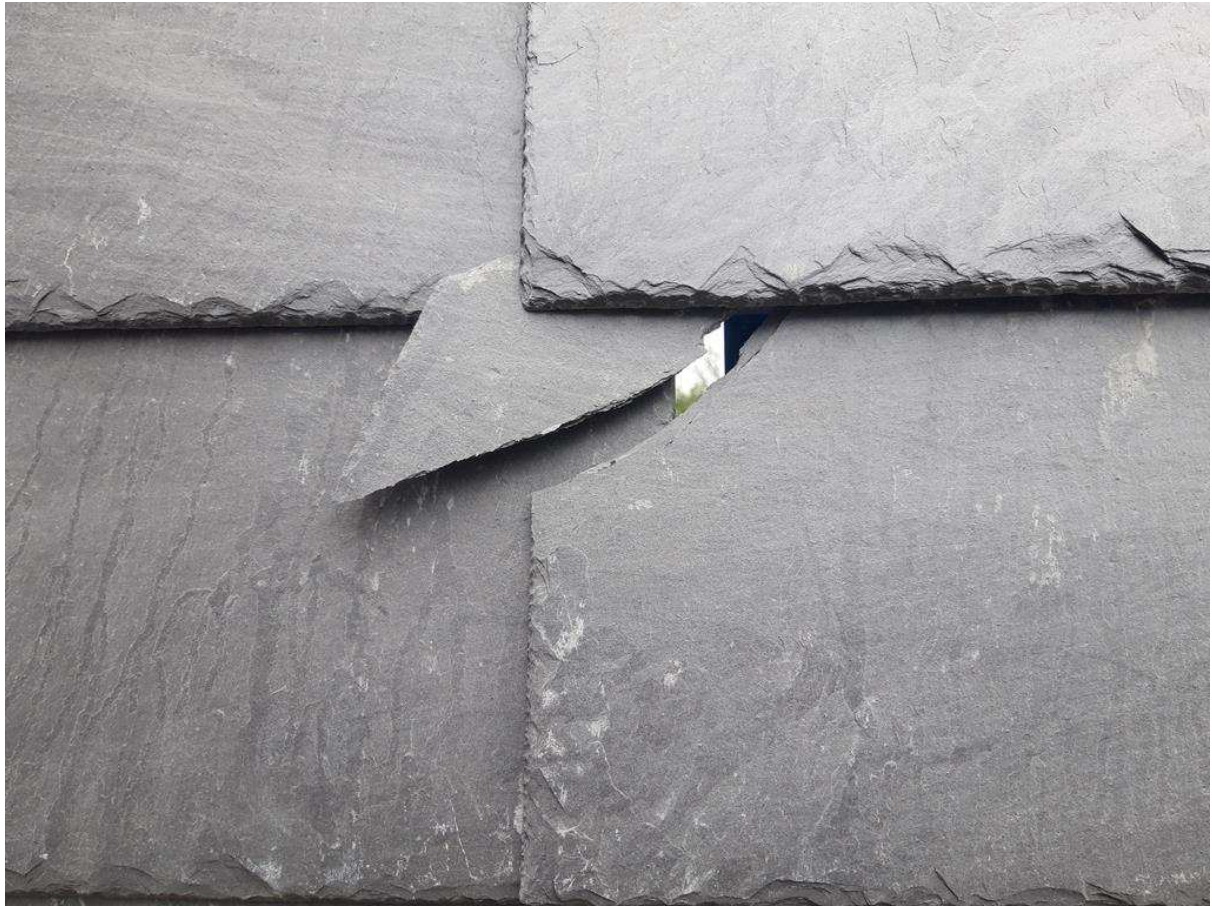
02:20-2:30	140-150	+84 and -84	No detachments or fissures observed
02:30-2:40	150-160	84-90	The piece of one of the cracked plates falls in 2:06 min
02:40-2:50	160-170	+90 and -90	No detachments or fissures observed

**Caída de trozo de placa en el minuto 2:06**
