ASTM E136
PERFORMANCE TEST REPORT

Report No.: F6825.01-121-24

CUPA PIZARRAS
Sobrado de Valdeorras, Ourense
Spain

PRODUCT TYPE: Slate Cladding Material
SERIES/MODEL: Cupa Pizarras Natural Slate

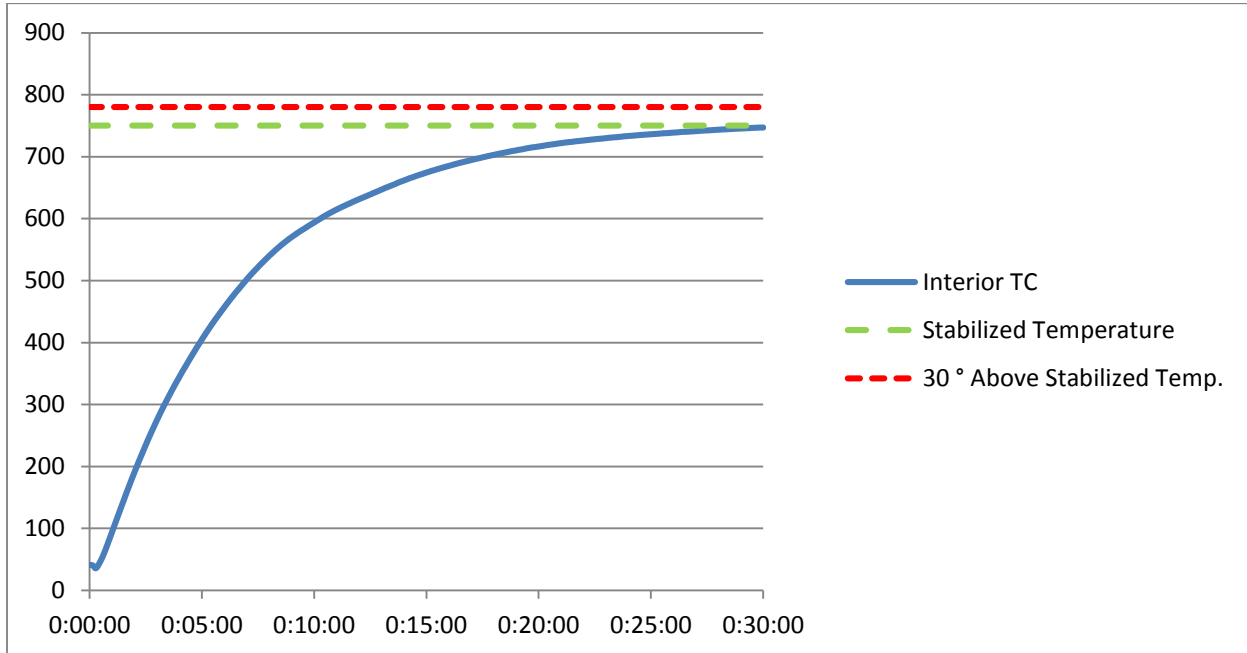
Interior Temperature Sample 1-1

Test Requirements	Observation	Pass / Fail
Percentage of Mass Loss < 50%	Initial Mass = 204.9 grams <u>Final Mass = 200.6 grams</u> Mass Loss = 2.0%	N/A
Flaming of Material	None	Pass
Temperature Rise > 30°C above Initial Temperature of Sample Interior	Initial Temp. = 750.0°C <u>Maximum Temp. = 747.2°C</u> Temperature Rise = -2.8°C	Pass
Temperature Rise > 30°C above Initial Temperature of Sample Surface	Initial Temp. = 750.0°C <u>Maximum Temp. = 760.0°C</u> Temperature Rise = 10.0°C	Pass

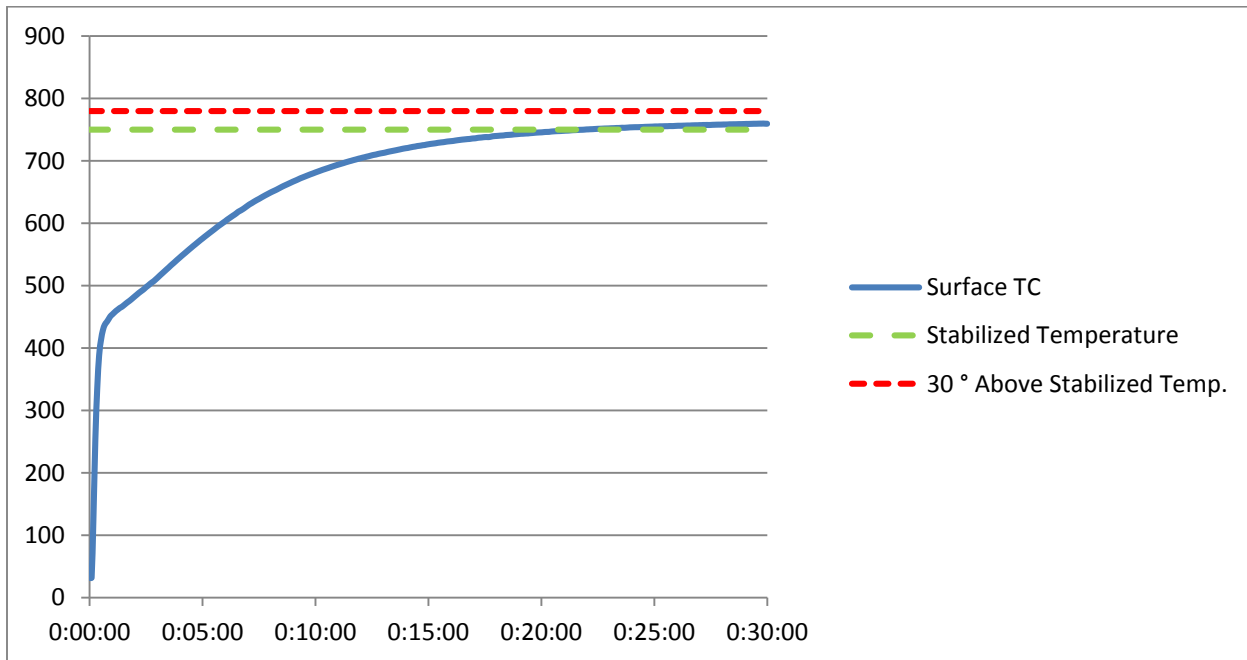
Surface Temperature Sample 1-1

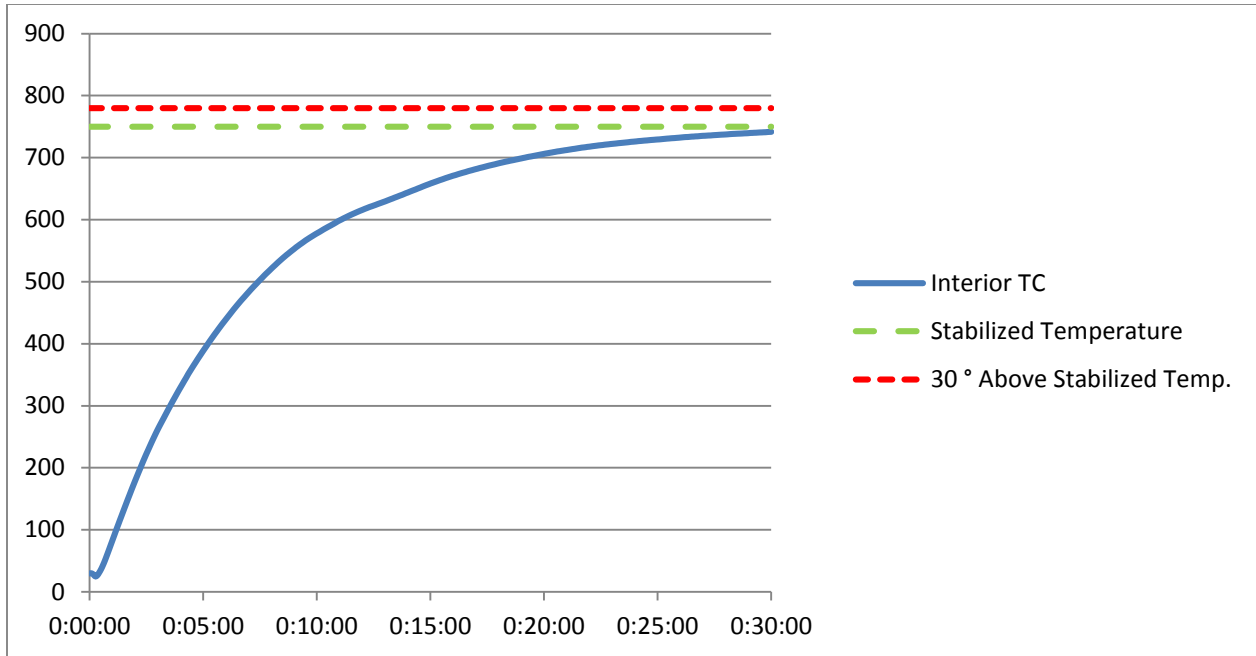
Interior Temperature Sample 1-2

Test Requirements	Observation	Pass / Fail
Percentage of Mass Loss < 50%	Initial Mass = 217.1 grams <u>Final Mass = 212.6 grams</u> Mass Loss = 2.0%	N/A
Flaming of Material	None	Pass
Temperature Rise > 30°C above Initial Temperature of Sample Interior	Initial Temp. = 750.0°C <u>Maximum Temp. = 741.5°C</u> Temperature Rise = -8.5°C	Pass
Temperature Rise > 30°C above Initial Temperature of Sample Surface	Initial Temp. = 750.0°C <u>Maximum Temp. = 756.3°C</u> Temperature Rise = 6.3°C	Pass

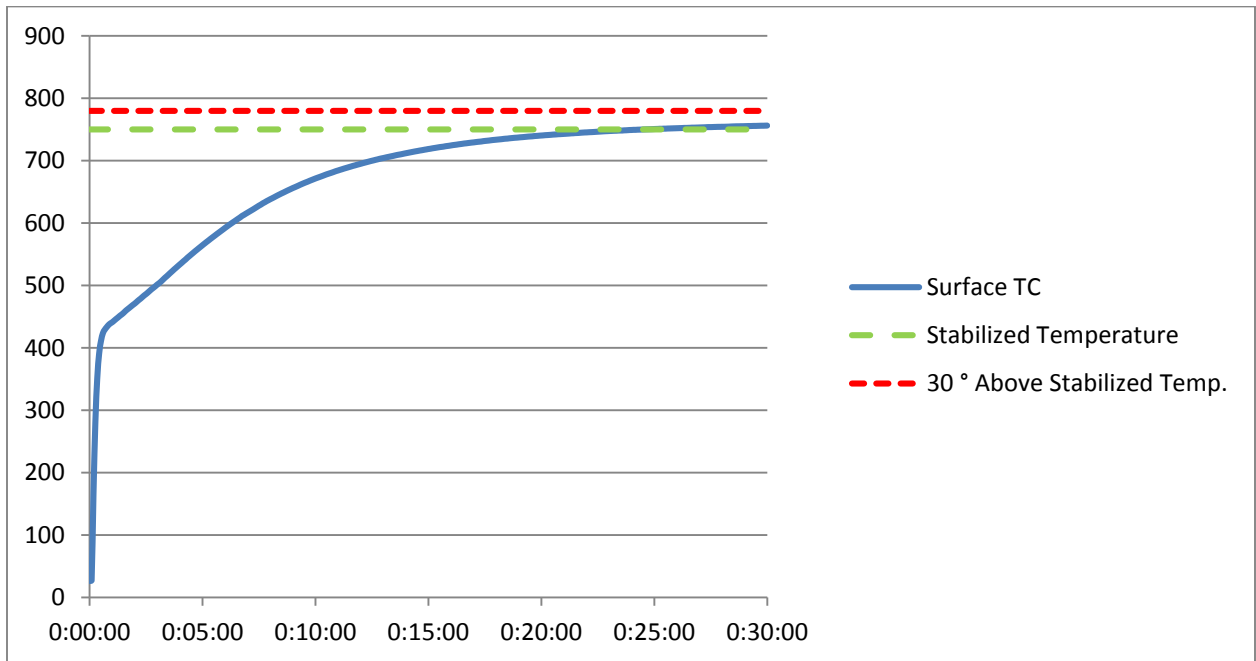
Surface Temperature Sample 1-2

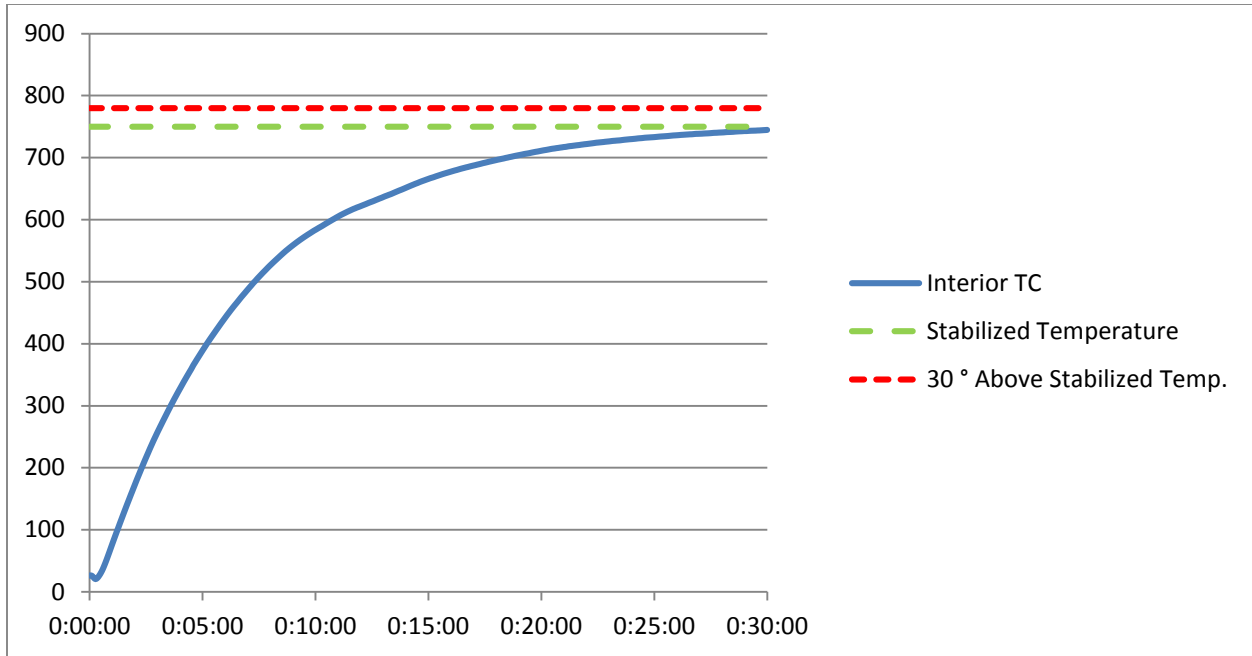
Interior Temperature Sample 1-3

Test Requirements	Observation	Pass / Fail
Percentage of Mass Loss < 50%	Initial Mass = 206.1 grams <u>Final Mass = 202.0 grams</u> Mass Loss = 2.0%	N/A
Flaming of Material	None	Pass
Temperature Rise > 30°C above Initial Temperature of Sample Interior	Initial Temp. = 750.0°C <u>Maximum Temp. = 744.5°C</u> Temperature Rise = -5.5°C	Pass
Temperature Rise > 30°C above Initial Temperature of Sample Surface	Initial Temp. = 750.0°C <u>Maximum Temp. = 756.9°C</u> Temperature Rise = 6.9°C	Pass

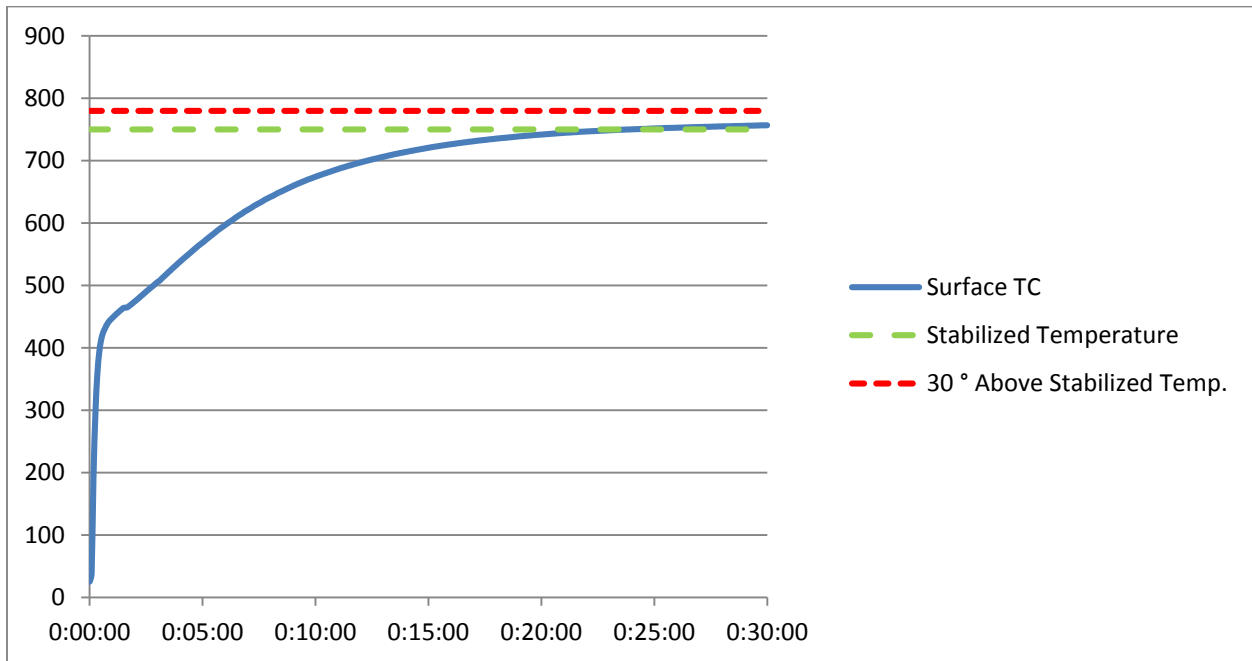
Surface Temperature Sample 1-3

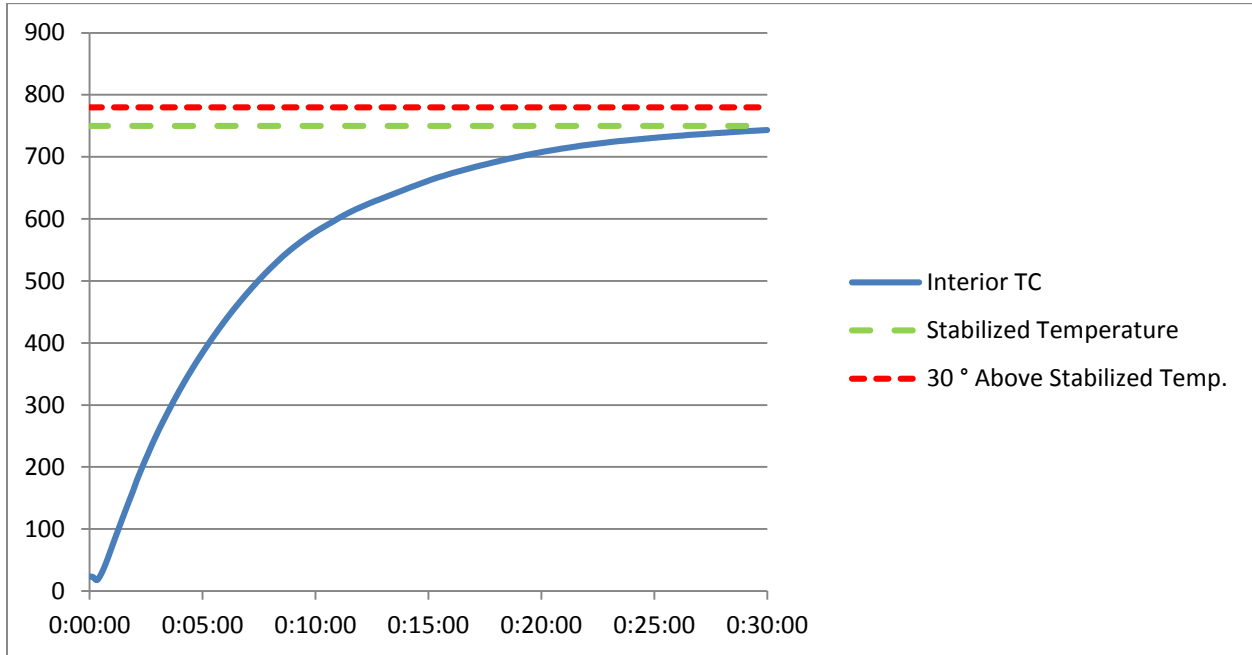
Interior Temperature Sample 1-4

Test Requirements	Observation	Pass / Fail
Percentage of Mass Loss < 50%	Initial Mass = 213.2 grams <u>Final Mass = 208.8 grams</u> Mass Loss = 2.0%	N/A
Flaming of Material	None	Pass
Temperature Rise > 30°C above Initial Temperature of Sample Interior	Initial Temp. = 750.0°C <u>Maximum Temp. = 743.2°C</u> Temperature Rise = -6.8°C	Pass
Temperature Rise > 30°C above Initial Temperature of Sample Surface	Initial Temp. = 750.0°C <u>Maximum Temp. = 753.6°C</u> Temperature Rise = 3.6°C	Pass

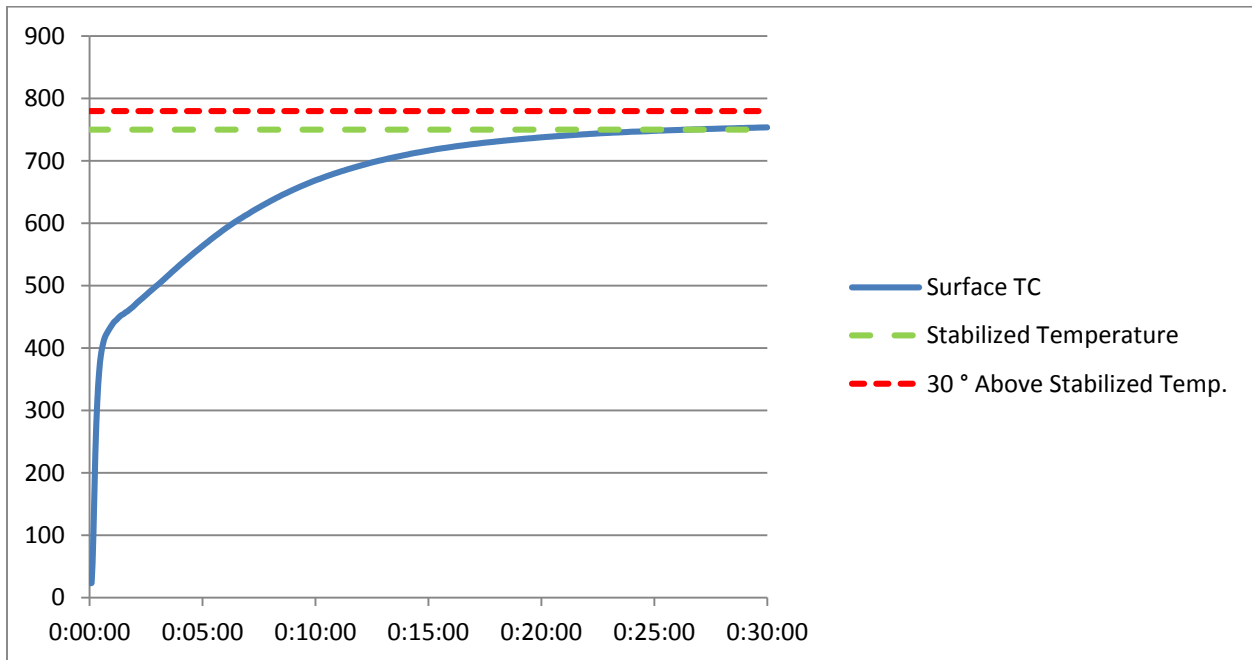
Surface Temperature Sample 1-4

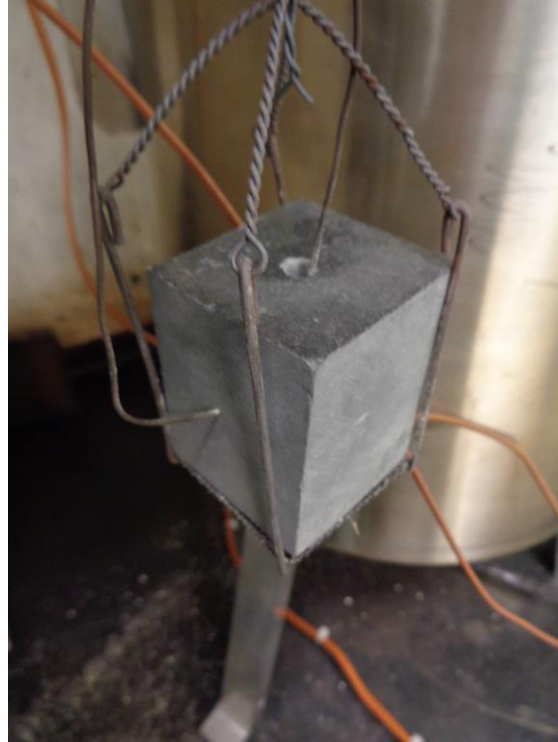
**Photo No. 1
Test Specimen**

3.2 Procedure: Four 1.5 inch x 1.5 inch x 2 inch samples were conditioned in an oven set at 60°C for 24 hours prior to testing. The samples were then instrumented with two thermocouples. One was placed on the outside surface and the other thermocouple was placed inside the center of the sample. After instrumentation, the sample was placed into a vertical furnace consisting of an enclosed refractory tube surrounded by a heating coil with a cone-shaped airflow stabilizer. The furnace was set at 750°C exposure and samples exposed for 30 minutes. Observations and data were recorded.

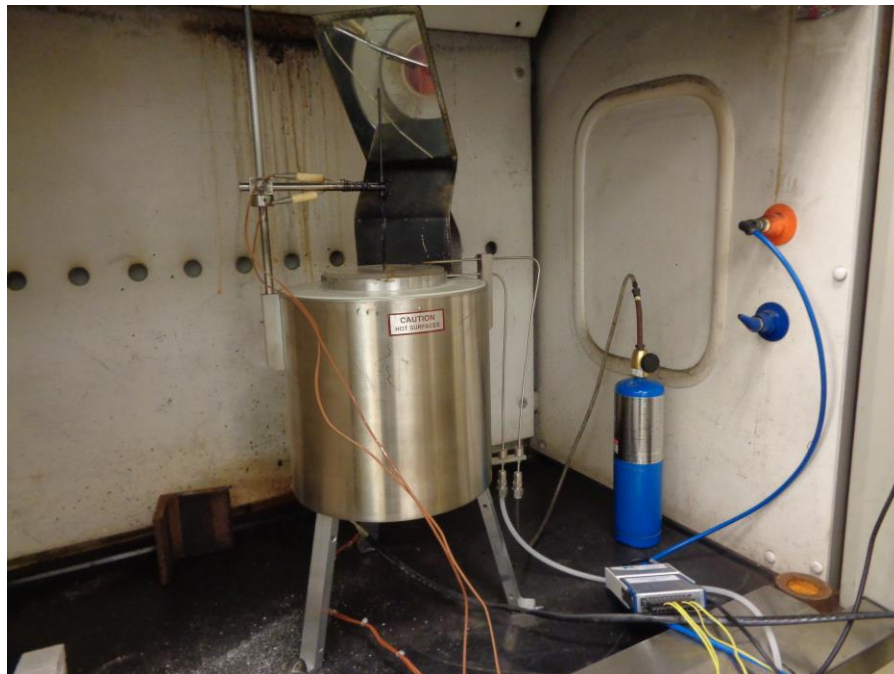
**Photo No. 2
Test Furnace Set-up**

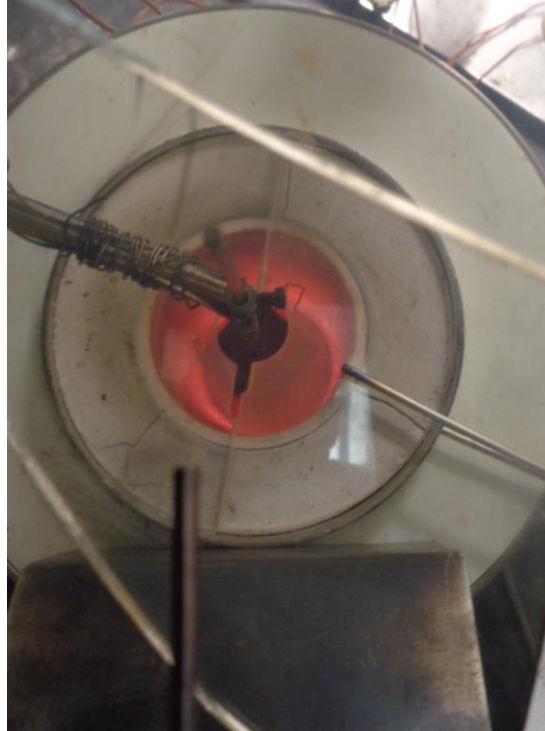
Photo No. 3
Typical Specimen (During Test)

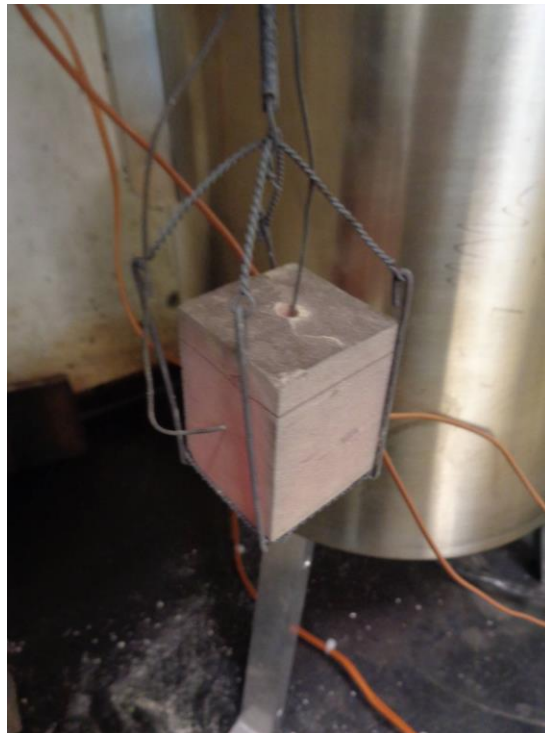
Photo No. 4
Typical Specimen (Post-test)
