## REPORT No. 087203-004-a

<b>CUSTOMER</b>	CUPA PIZARRAS S.A.
<b>CONTACT PERSON</b>	MARÍA PÉREZ
<b>ADDRESS</b>	LA MEDUA, s/n 32330 SOBRADELO DE VALDEORRAS (ORENSE), SPAIN
<b>PURPOSE</b>	RECOMMENDED DYNAMIC AND STATIC TEST METHOD FOR DETERMINING THE SEISMIC DRIFT CAUSING GLASS FALLOUT FROM A WALL SYSTEM (AAMA 501.6-18, AAMA 501.4-18)
<b>TESTED SAMPLE</b>	VENTILATED CLADDING REF.: "CUPACLAD 101 PARALLEL"
<b>RECEPTION DATE</b>	06.07.2020
<b>TEST DATE</b>	06.07.2020 – 09.07.2020
<b>ISSUE DATE</b>	24.07.2020
<b>TRANSLATION DATE</b>	18.12.2020

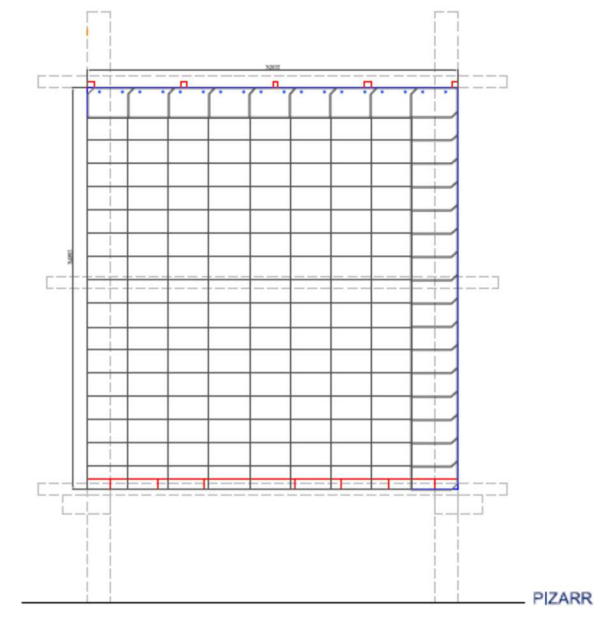
Tested sample (the rest of the sample drawings can be found in Annex I of this report and the sample photographs in Annex II).
