## REPORT No. 087203-002-a

<b>CUSTOMER</b>	CUPA PIZARRAS S.A.
<b>CONTACT PERSON</b>	MARÍA PÉREZ
<b>ADDRESS</b>	LA MEDUA, s/n 32330 SOBRADELO DE VALDEORRAS (ORENSE), SPAIN
<b>PURPOSE</b>	RECOMMENDED DYNAMIC AND STATIC TEST METHOD FOR DETERMINING THE SEISMIC DRIFT CAUSING GLASS FALLOUT FROM A WALL SYSTEM (AAMA 501.6-18, AAMA 501.4-18)
<b>TESTED SAMPLE</b>	VENTILATED CLADDING REF.: "CUPACLAD 101 LOGIC 50 X 25"
<b>RECEPTION DATE</b>	06.07.2020
<b>TEST DATE</b>	06.07.2020 – 09.07.2020
<b>ISSUE DATE</b>	24.07.2020
<b>TRANSLATION DATE</b>	18.12.2020

On 6 July TECNALIA received from the company CUPA PIZARRAS S.A. the components for the assembly of the cladding sample with reference "CUPACLAD 101 LOGIC 50 X 25". Using these components from CUPA PIZARRAS , a sample measuring 3,200x3,500 mm was constructed

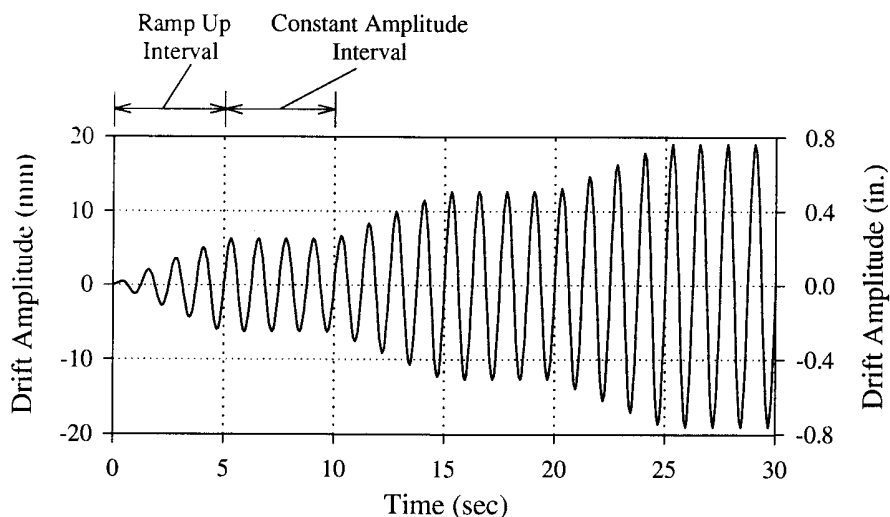
Figure 1: Graphic description of the first 30 seconds of the test.

The movement to be applied to the cladding consists of a concatenated series of ramp up intervals followed by a series of constant amplitude intervals. (Figure 1 and Figure 2)

Each ramp up and constant amplitude interval shall consist of 4 sinusoidal cycles. The ramp up intervals shall be performed at a frequency of  $0.8+0.1/-0.0$  Hz for a displacement of up to  $\pm 75$  mm or less, and  $0.4+0.1/-0.0$  Hz for a displacement greater than 75 mm.

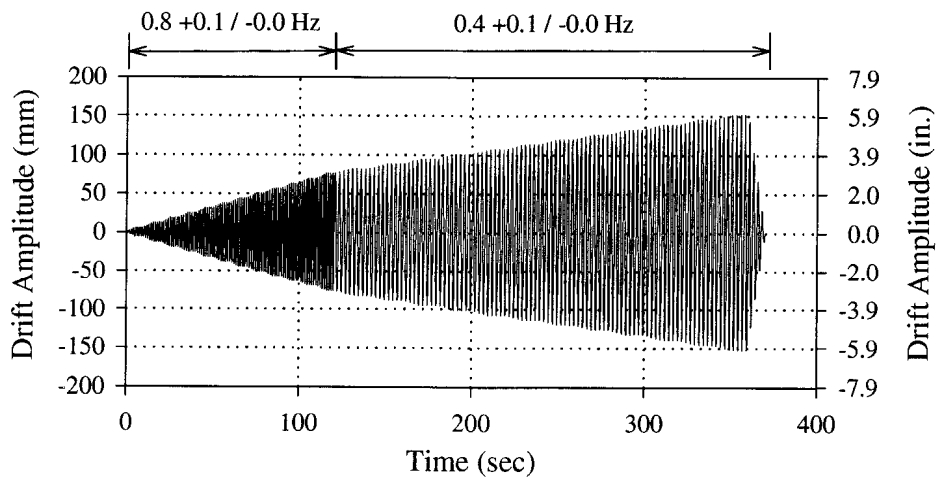
(b) Full Crescendo Test

Figure 2: Graphic description of the complete test

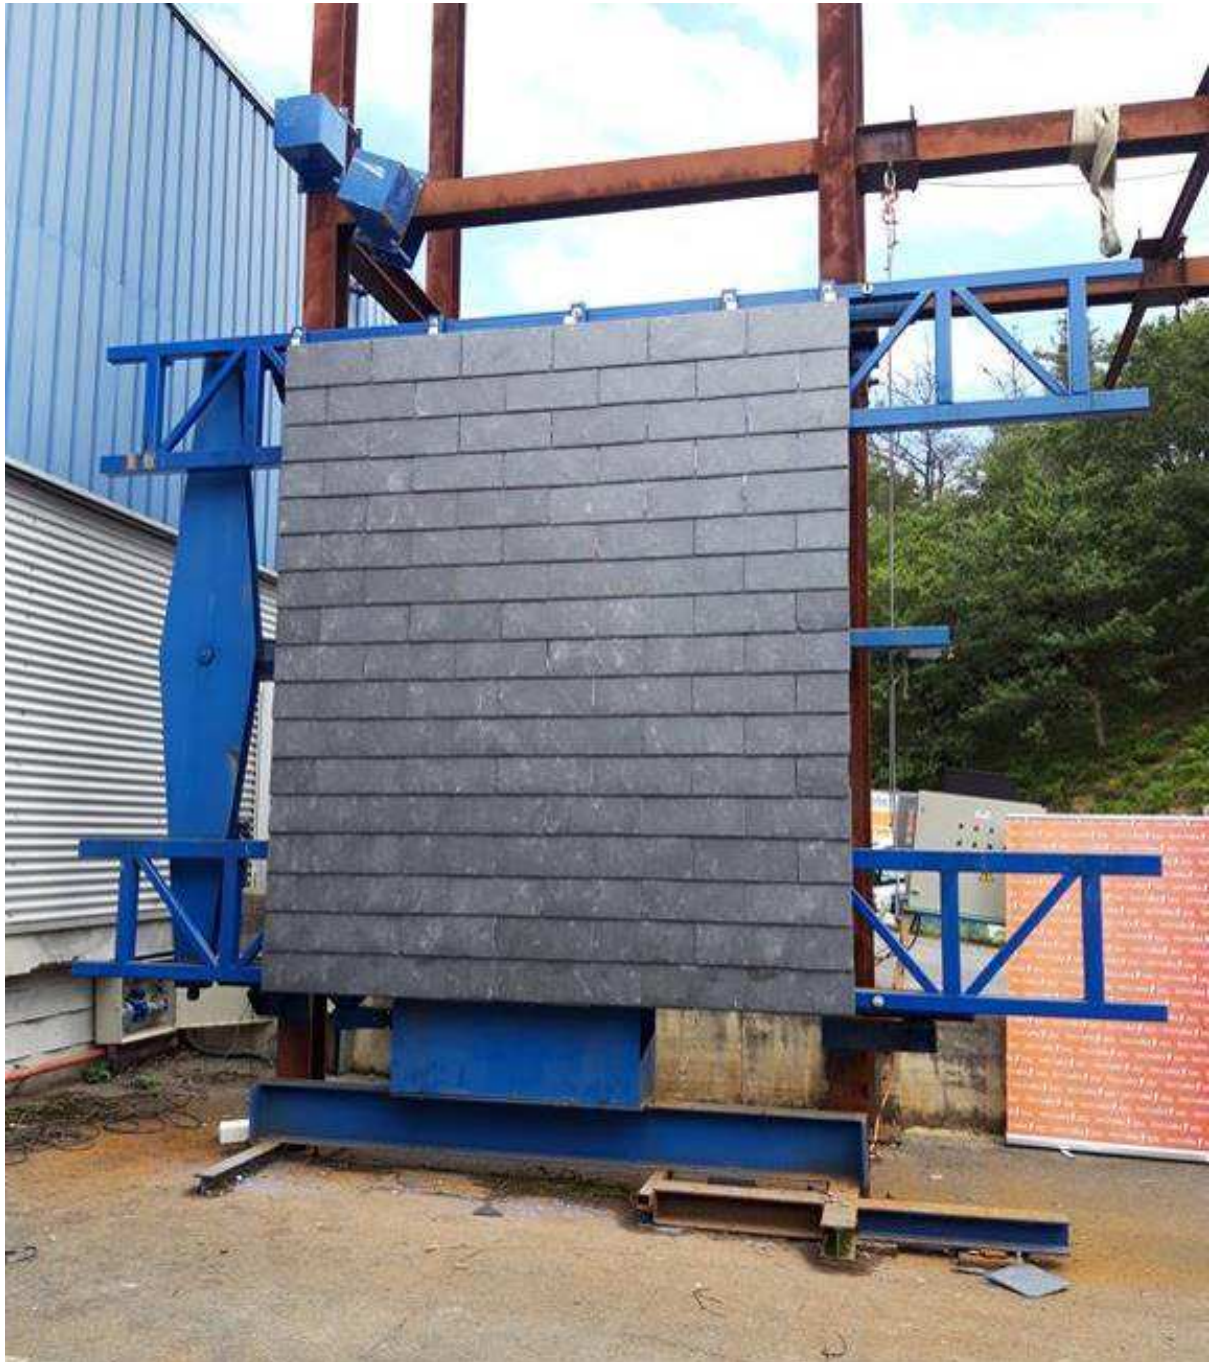
Photograph 1: Tested sample (front view)

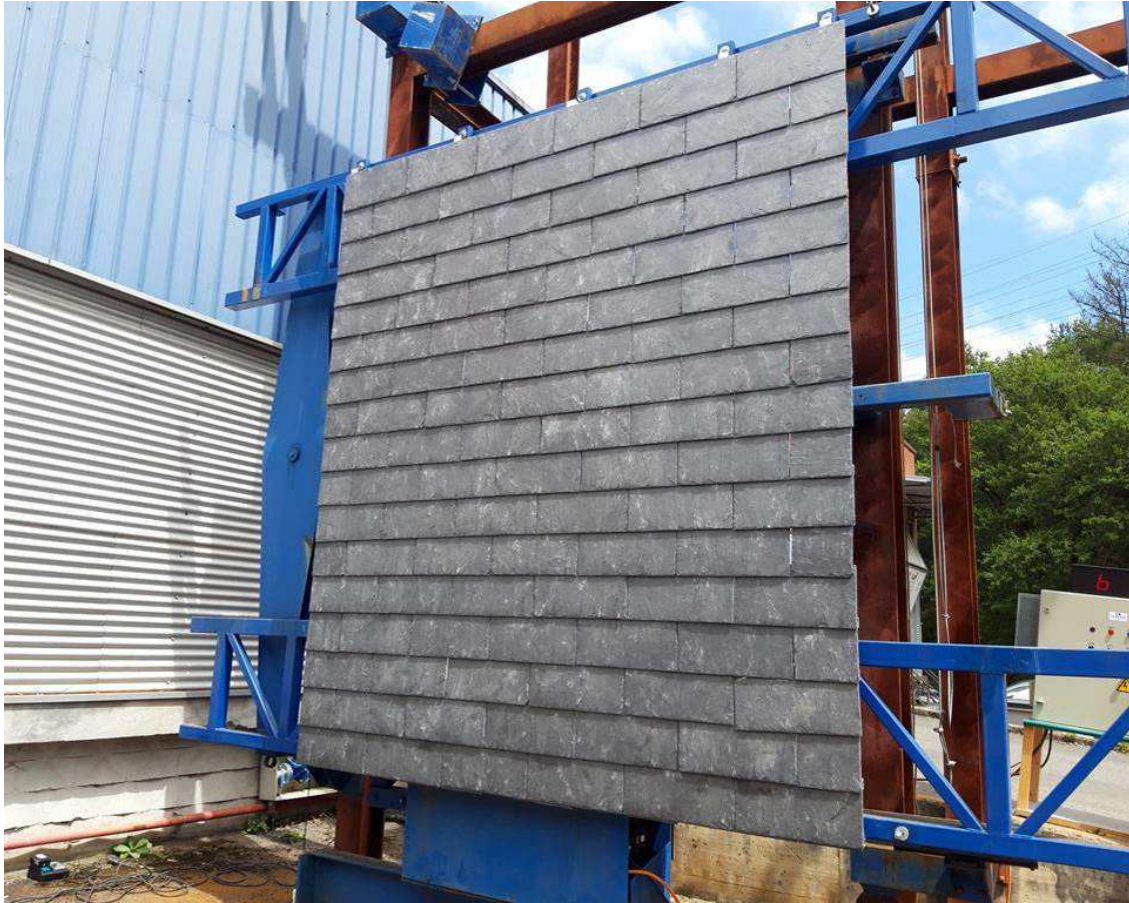
Photograph 2: Tested sample (side view)

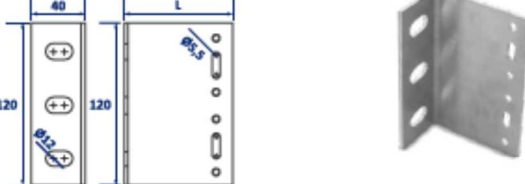
<p>Length : 75-250 mm                      Width : 40 mm                      Height : 120 mm                      Thickness : 3 mm                      Material : 6060-T6</p>
<p>VERTICAL L PROFILE</p>

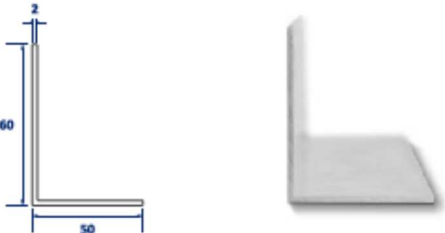
<p>Length : 6000 mm                      Width : 50 mm                      Height : 60 mm                      Thickness : 3 mm                      Material : 6060-T6</p>
<p>SCREW (SUBSTRUCTURE)</p>
